melett

QUALITY REPLACEMENT TURBOCHARGER PARTS

COMPONENT VARIATIONS ①

SHAFT & WHEEL DEVELOPMENT

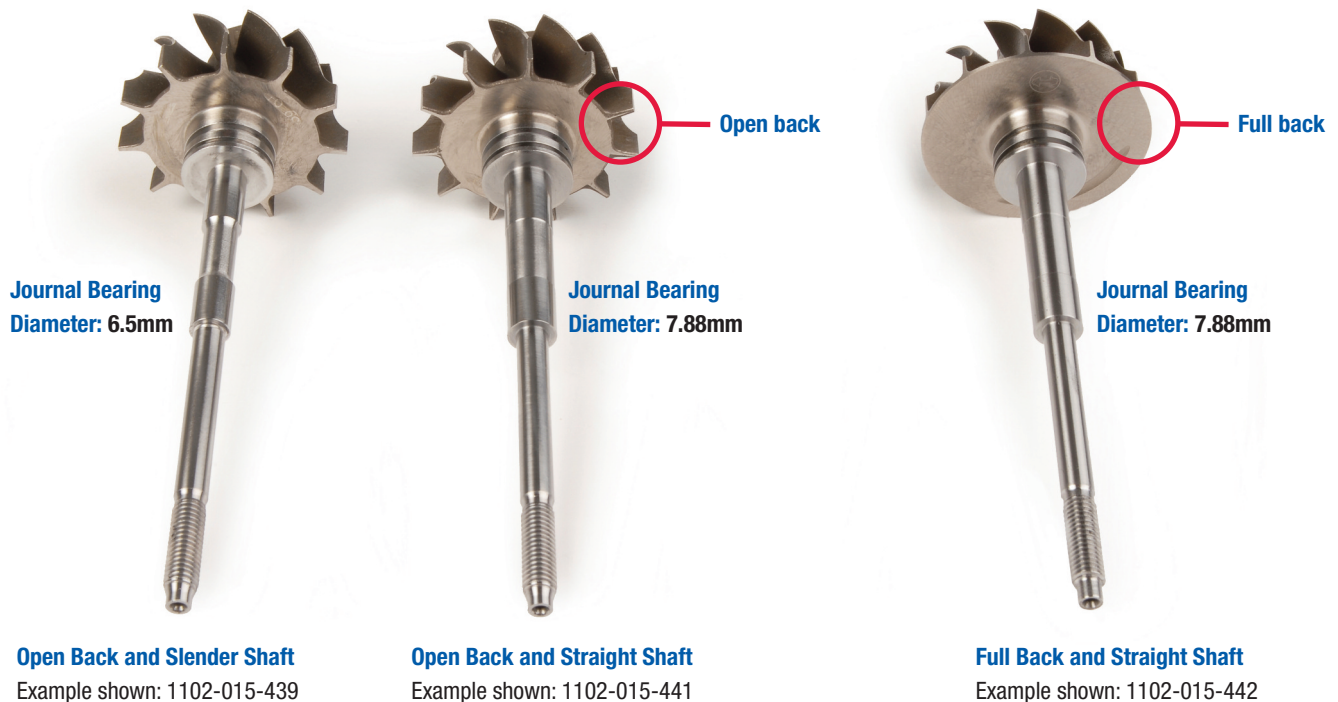
Traditionally, a shaft and wheel has an open back with a slender or straight shaft. To strengthen the turbine wheel, Melett has developed a **full back** shaft and wheel solution that reduces the risk of fatigue on the inducer diameter.

Original GT15 Shaft and Wheels

Melett Variation: GT15-25 Straight shaft - increased radius to reduce stress.

Why two different types? Early turbochargers incorporated a slender shaft in their design. This shaft was perceived to be lighter and provide less resistance, increasing performance. However, with advancements in turbocharger technology, a straight shaft was developed which provides extra strength and rigidity, and in theory makes the turbocharger easier to balance. The slender shaft is currently being phased out by the turbocharger OE's, and all GT15 applications, and upwards, will incorporate a straight shaft.

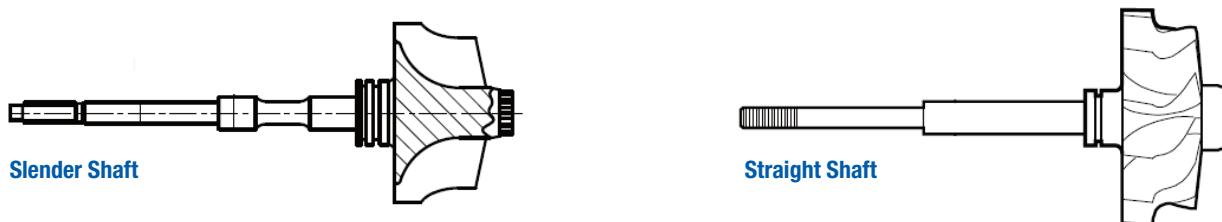
Figure 1: Illustrations of a typical slender shaft and straight shaft.

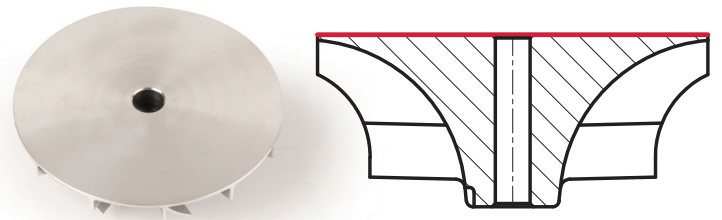
Flatback: Earliest design of compressor wheel and still used by some manufacturers.

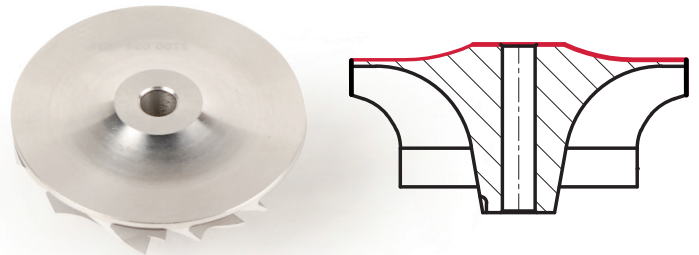
Superback: This design was introduced due to the increased speeds which the turbochargers rotate, because of the speed increase the force on the compressor wheel increases significantly, in particular the exducer diameter of the compressor wheel suffered the most. This is the point which rotates the fastest and is therefore under the most stress. The Superback reinforces the back face of the compressor wheel preventing the compressor wheel tearing from the bottom up.

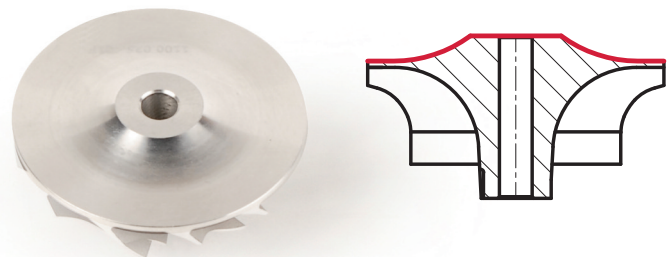
Deep Superback: An exaggerated design of the Superback, generally used on more recent applications. Again, one theory is due to the increasing rotation speeds of the turbo.

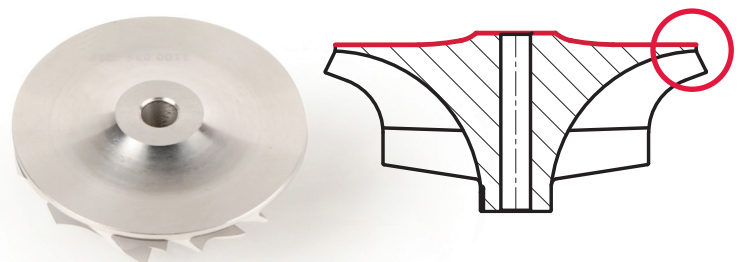
Deep Superback - Extended tip: This design promotes greater airflow providing a faster boost response at lower engine speeds. The extended tip design increases the efficiency of the Superback compressor wheel at higher boost pressures.

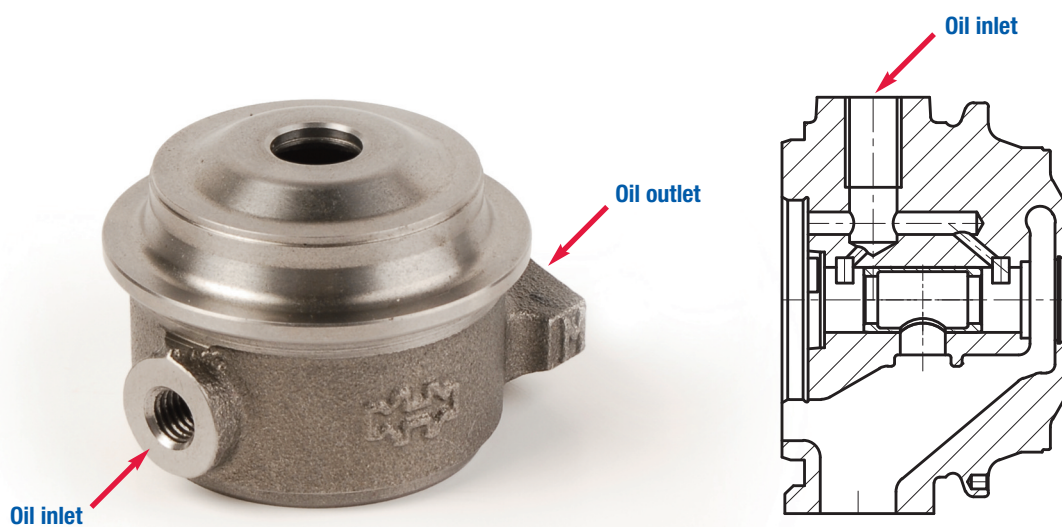
Air Cooled: Ambient air and oil act as a cooling mechanism.

Melett Example: IHI – RHF4 / RHV4 / RHF4V / RHF5 / RHV5 / RHF5V

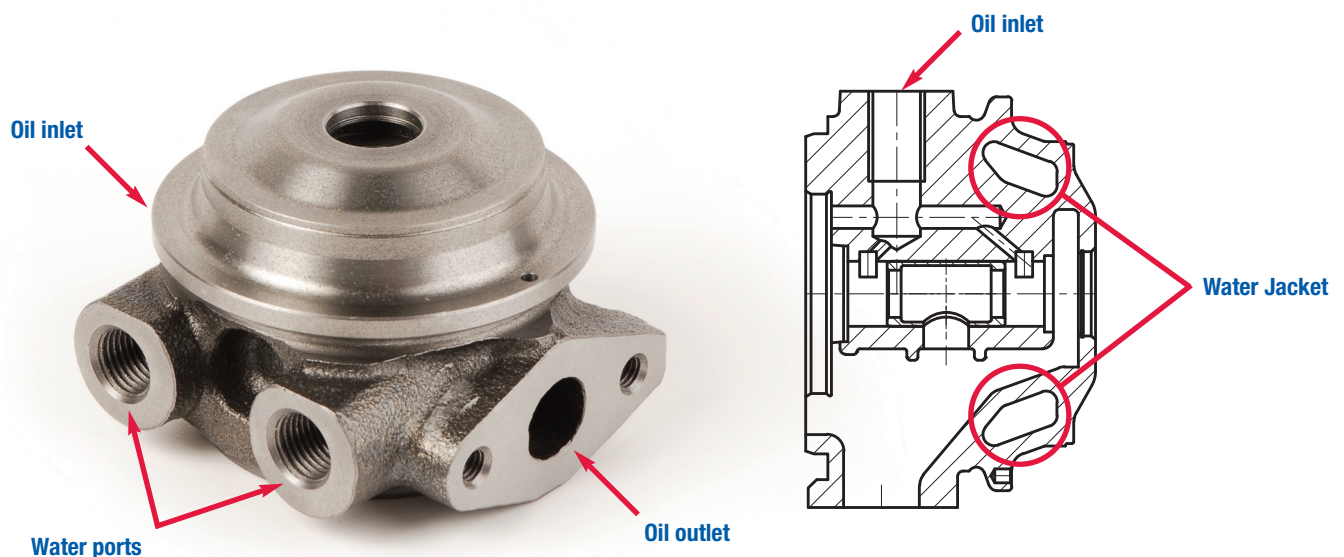
Water Cooled: High temperature applications need extra cooling to perform efficiently.

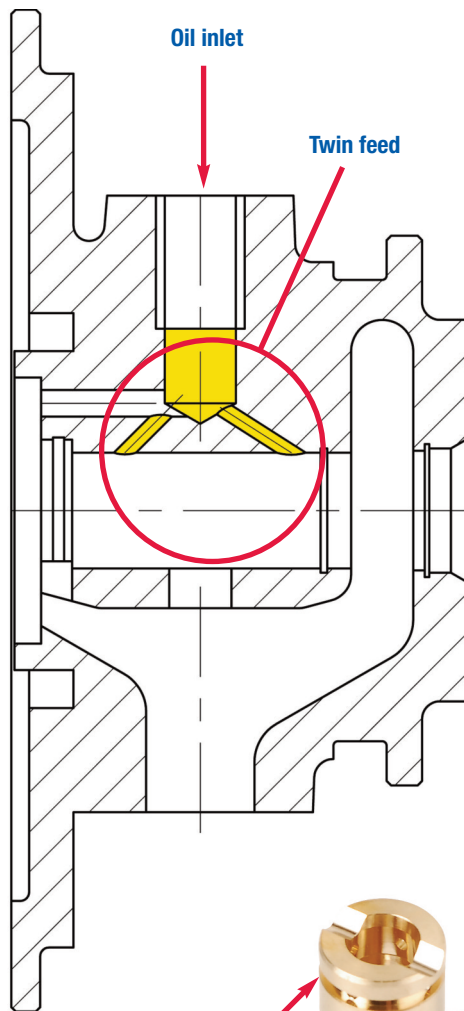
1302-003-100

Twin Feed

Oil grooves

Please note: Before repair please ensure you have the right journal bearing for the bearing housing - failure will occur if they are mixed.

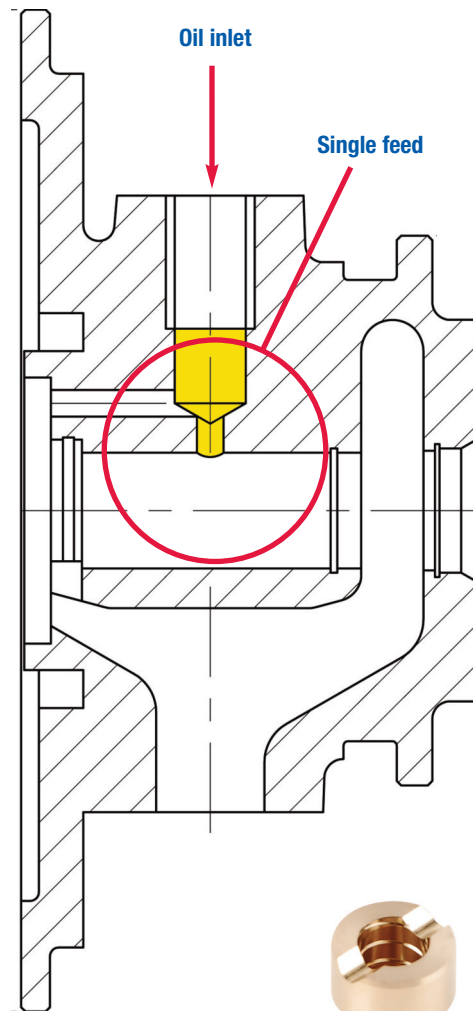
1302-004-100

Single Feed

Oil hole
